Allstate Home Inspections LLC

6 Hedge Ln
Merrick NY 11566-4405
Inspector: Andrew Voutsinas
NYS # 16000069743

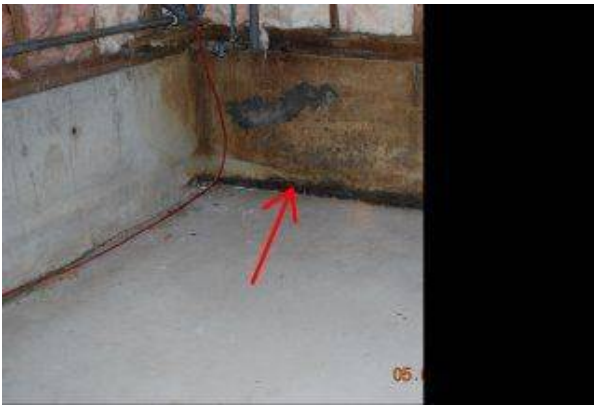
Photo 1-1
appears to be mold

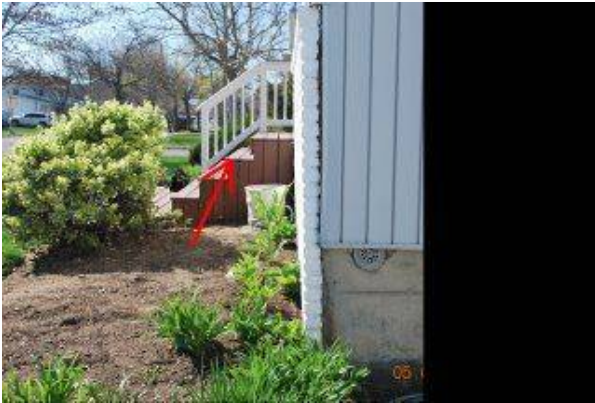
Handrails at one or more flights of stairs were missing. This is a potential fall hazard. Handrails should be installed at stairs with four or more risers or where stairs are greater than 30 inches high. Recommend that a qualified contractor install handrails where missing and per standard building practices.

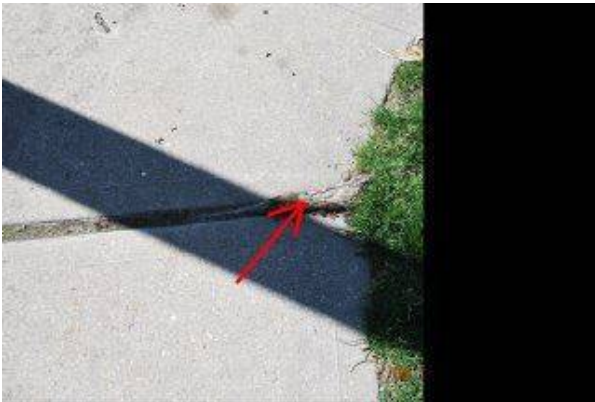
Cracks, holes, settlement, heaving and/or deterioration resulting in trip hazards were found in the sidewalks or patios. For safety reasons, recommend that a qualified contractor repair as necessary to eliminate trip hazards.

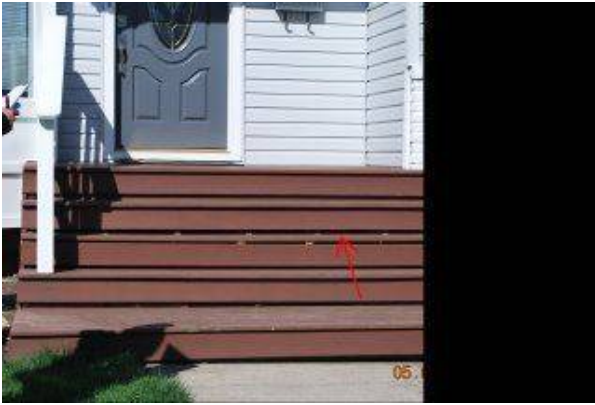
One or more treads at exterior stairs were loose. This is a potential fall hazard. Recommend that a qualified person repair as necessary.

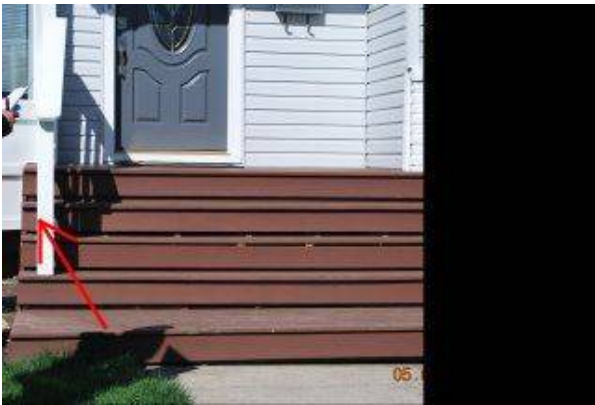
Guardrails at one or more locations with drop-offs higher than 30 inches were loose, and pose a fall hazard. Recommend that a qualified person repair guardrails as necessary.

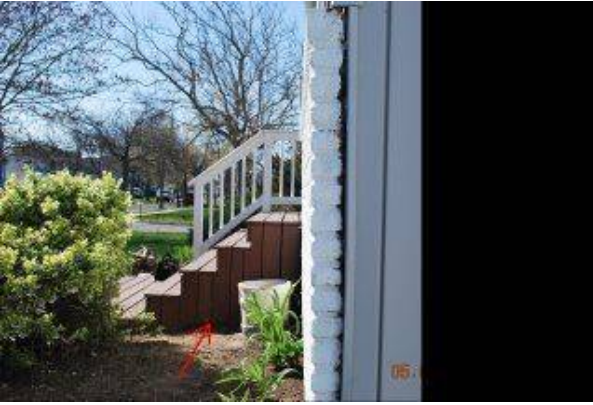
Photo 7-1
wood touching soil

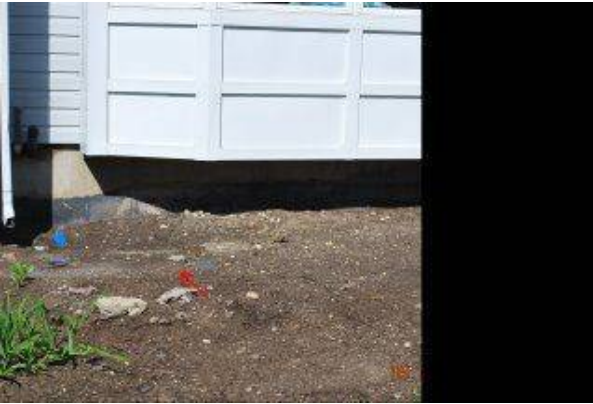
Photo 8-1
low area depression water not draining correctly

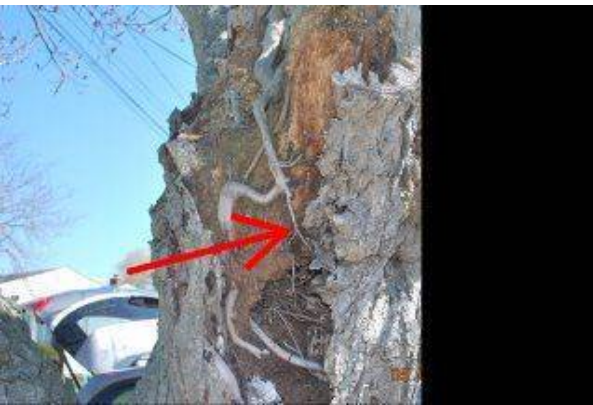
Photo 9-1
carpenter Aunt infestation at front tree

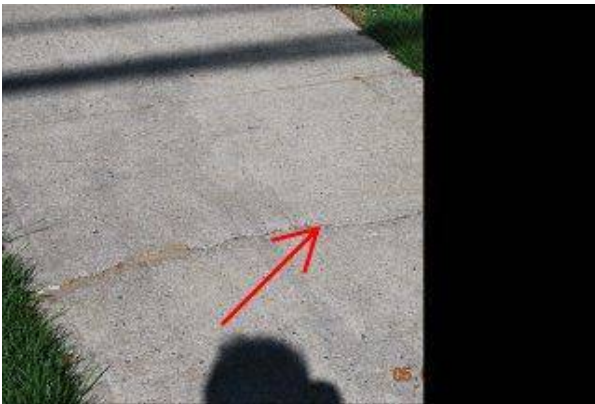
Photo 11-1
sidewalk cracks

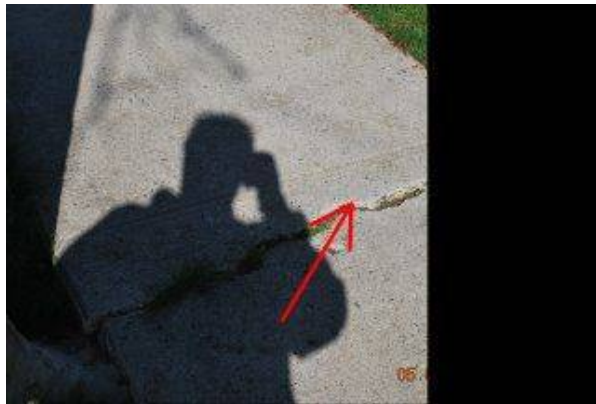
Photo 11-2
sidewalk cracks

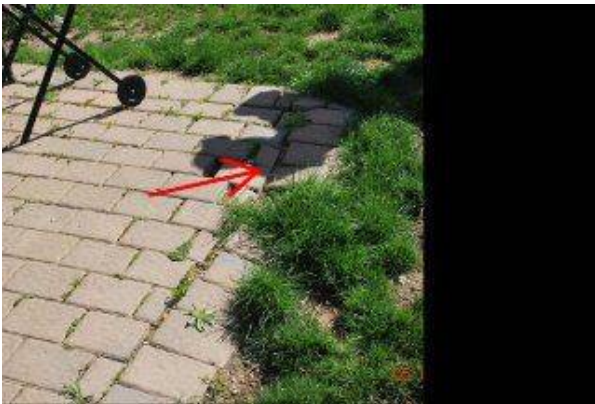
Photo 11-3
Pavers falling apart

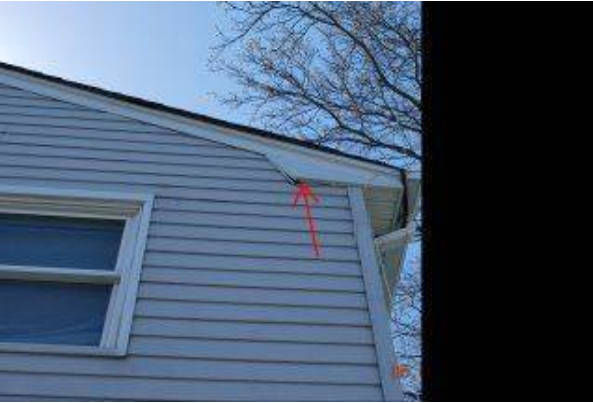
Photo 12-1
aluminum fascia cover loose

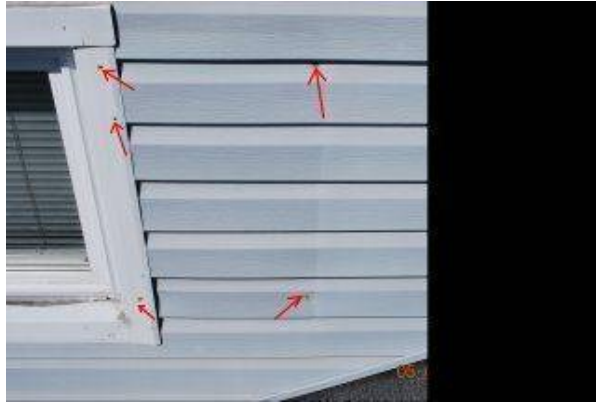
Photo 12-2
Open holes not sealed

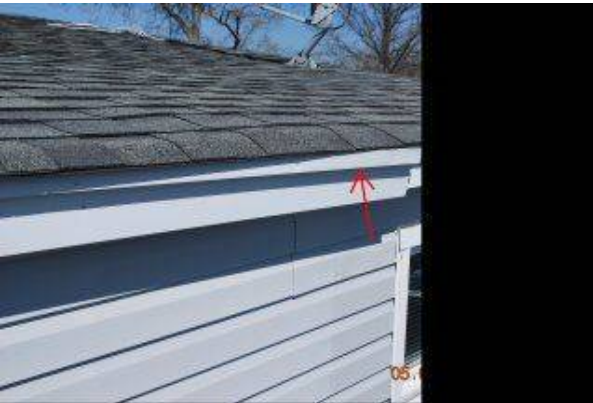
Photo 12-3
loose fascia capping

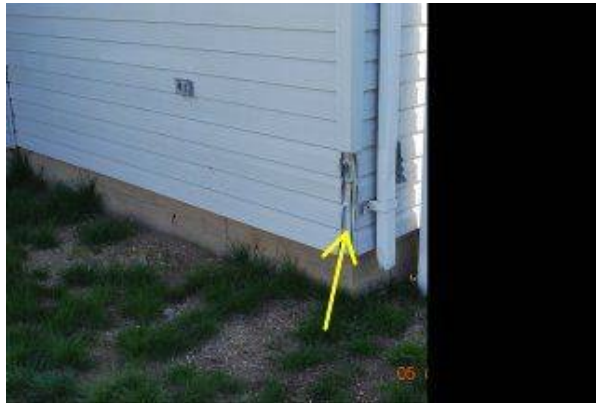
Photo 12-4
Corner siding post damaged/missing

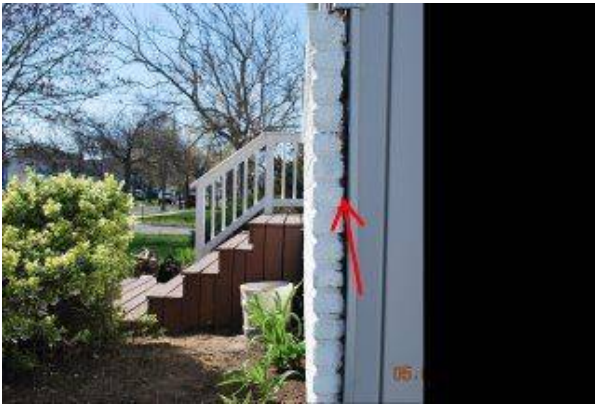
Photo 13-1
Brick Vanier pulling away from building

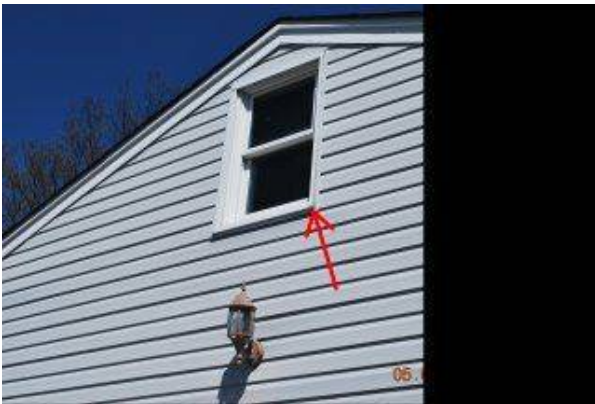
Photo 14-1
Corner of window capping loose

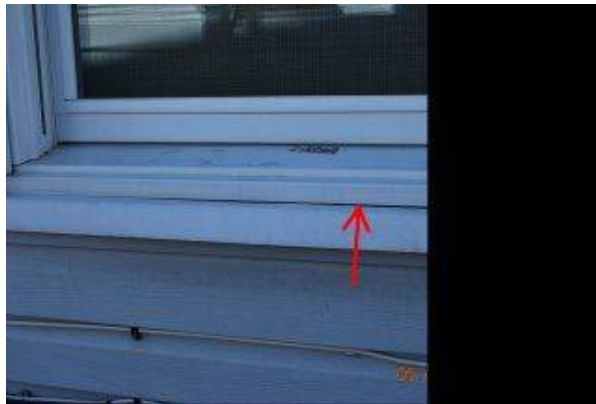
Photo 14-2
missing caulk

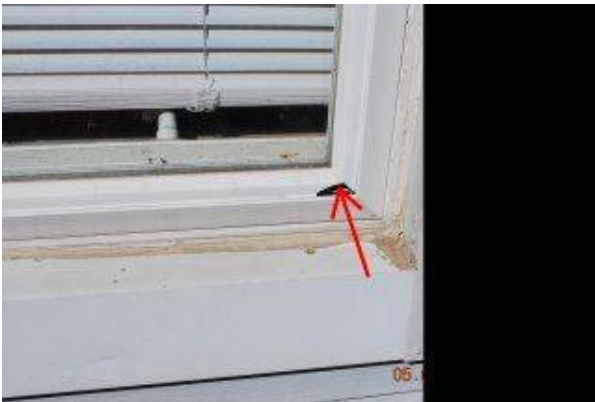
Photo 14-3
Broken window capping

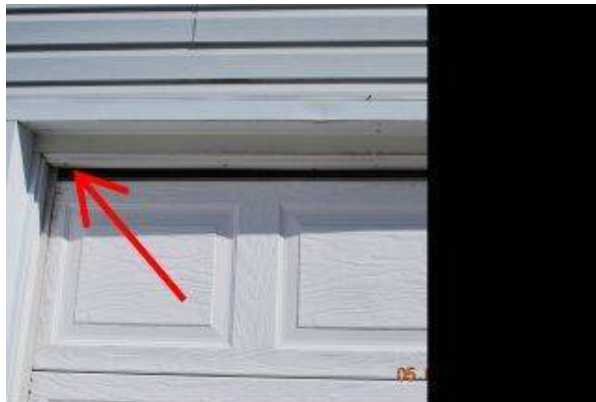
Photo 14-4
Gap at garage door very large

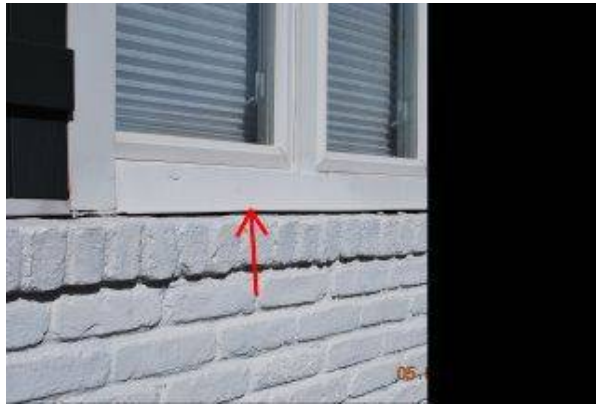
Photo 14-6
window missing caulk

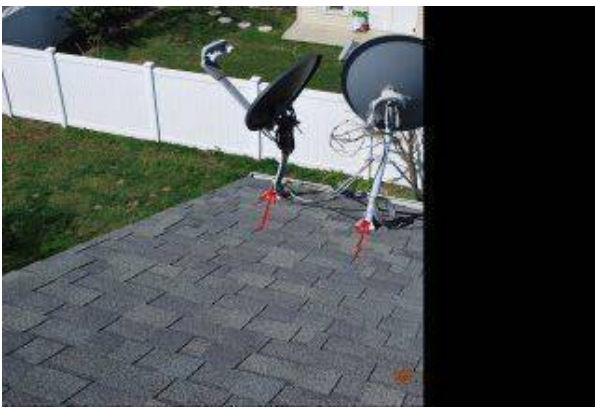
Photo 15-1
Satellite screw penetrations not caulked

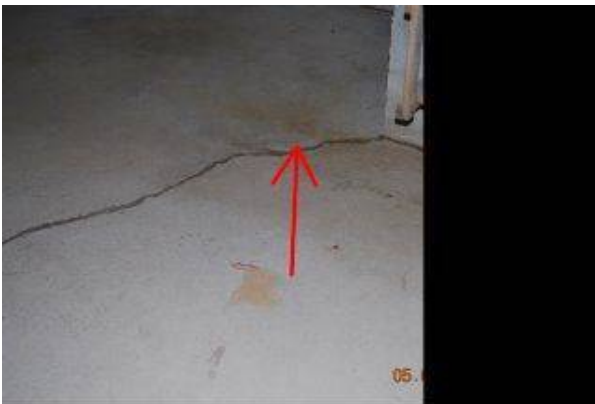
Photo 16-1
slab crack in crawl space floor

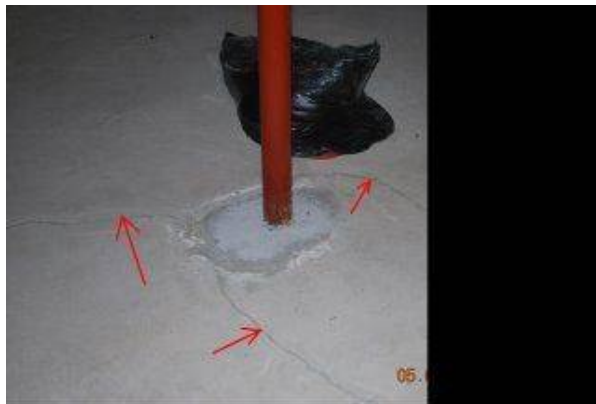
Photo 16-2
slab cracks in crawl space floor

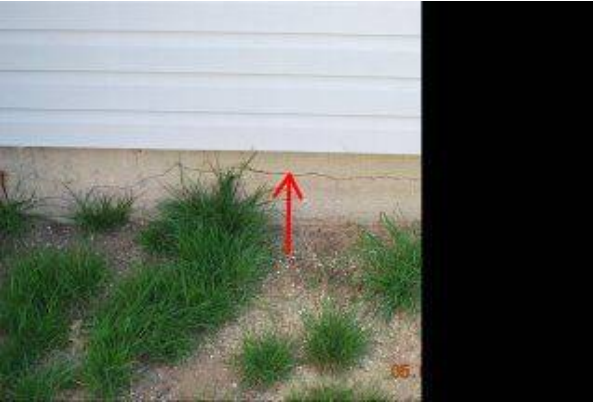
Photo 16-3
horizontal foundation cracks

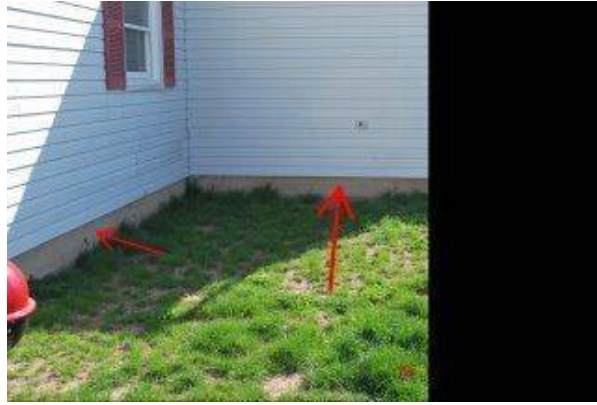
Photo 16-4
Horizontal foundation cracks

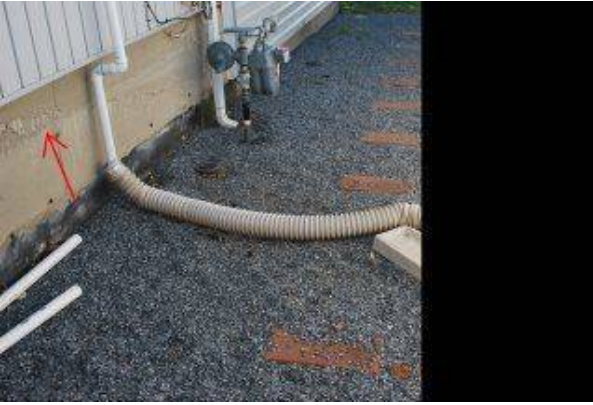
Photo 16-5
horizontal foundation cracks

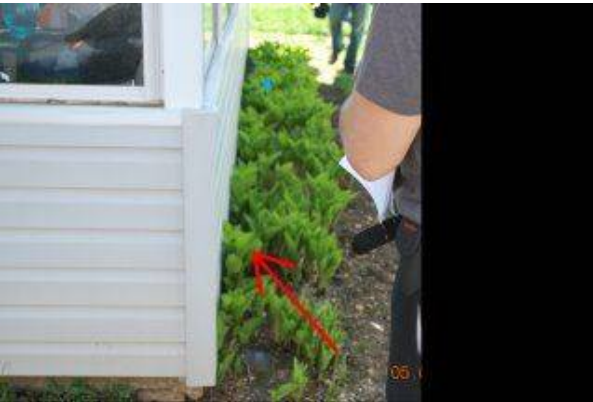
Photo 17-1
vegetation too close to building structure

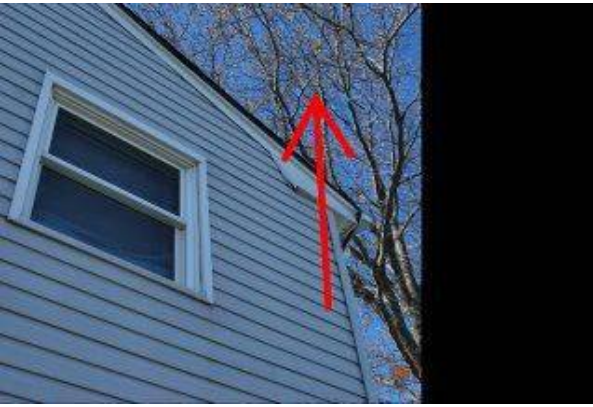
Trees were in contact with or were close to the building at one or more locations. Damage to the building can occur, especially during high winds, or may have already occurred (see other comments in this report). Recommend that a qualified tree service contractor or certified arborist remove trees as necessary to prevent damage to the building exterior.

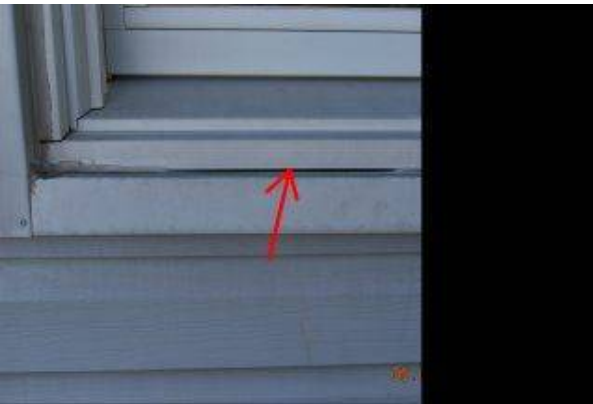
Caulk was missing in some areas. For example, around windows. Recommend that a qualified person renew or install caulk as necessary. Where gaps are wider than 1/4 inch, an appropriate material other than caulk should be used. For more information, visit: <http://www.reporthost.com/?CAULK>

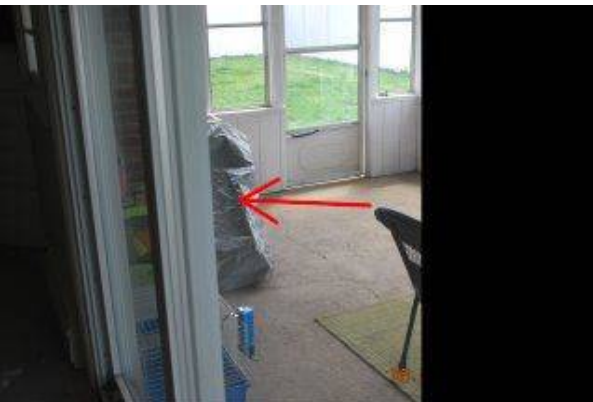
Firewood was stored so that it was in contact with or close to the building exterior. This is a conducive condition for wood-destroying organisms. Recommend storing firewood outdoors in an open area, and as far away from buildings as practical to keep insects away from buildings. For more information visit: <http://www.reporthost.com/?FWWDI>

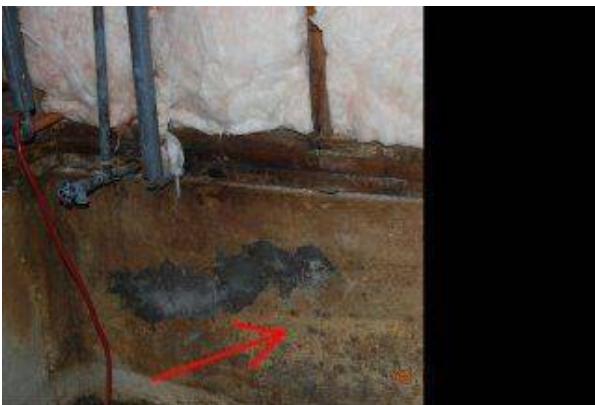
Ideally, water should not enter crawl spaces, but if water must be controlled after it enters the crawl space, then typical repairs include installing trenches, gravity drains and/or sump pump(s) in the crawl space.

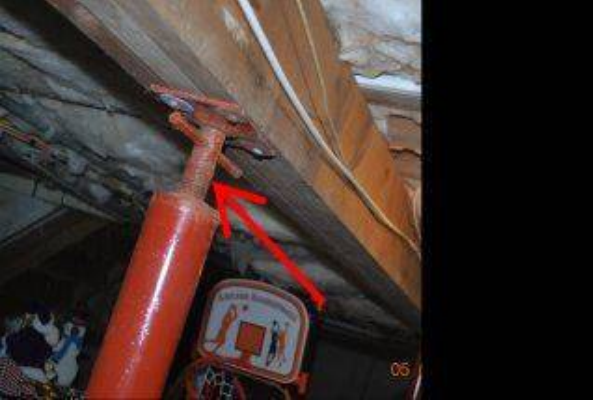
Photo 22-1
use of temporary support columns

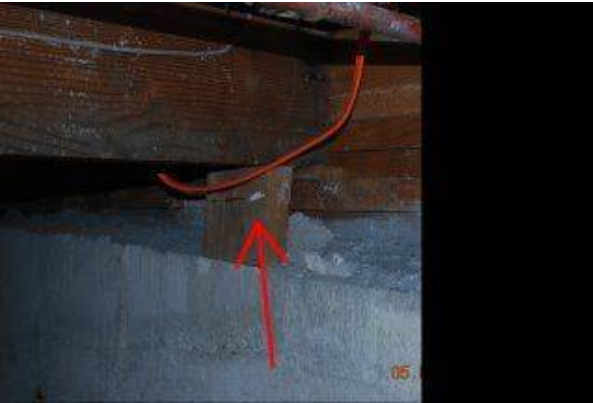
Photo 23-1
support of beam inadequate

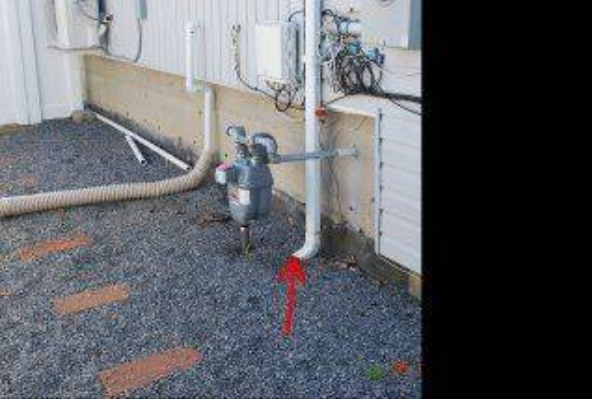
Extensions such as splash blocks or drain pipes for one or more downspouts were missing. Water can accumulate around the building foundation or inside crawl spaces or basements as a result. Recommend that a qualified person install, replace or repair extensions as necessary so rainwater drains away from the structure.

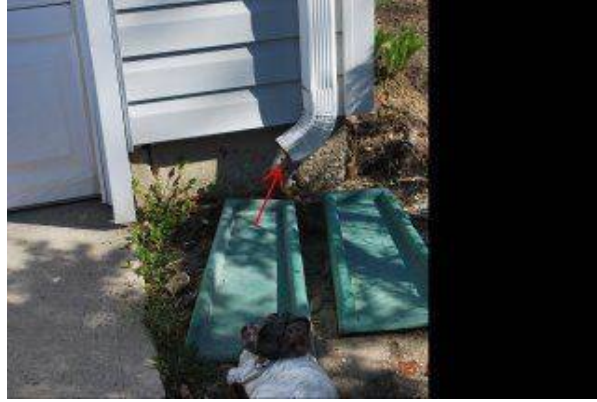
Down spout too close to foundation

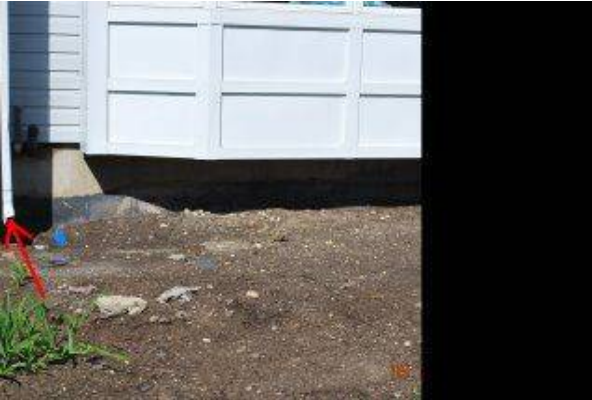
down spout too close to foundation

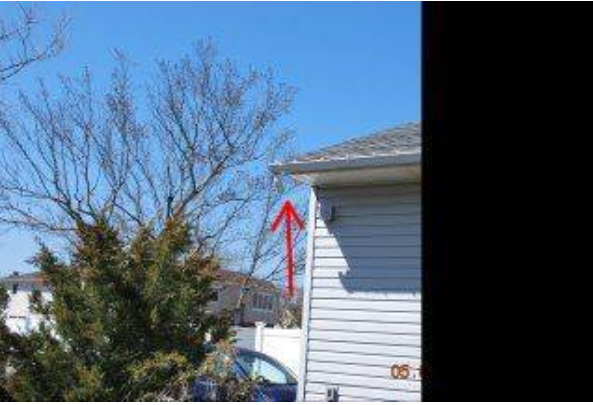
Photo 26-1
Missing section of down spout

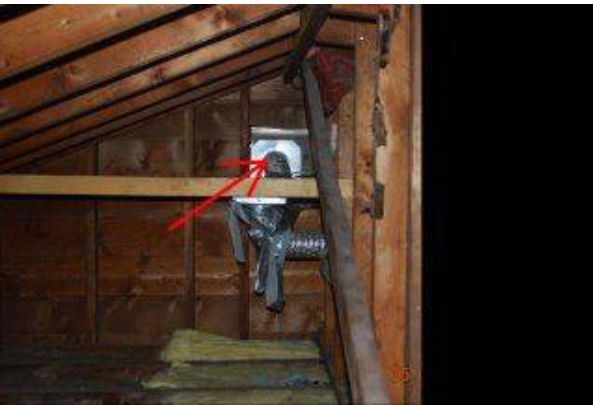
Photo 27-1
exhaust fan mounted on inside of gable vent blocking it from properly venting the attic

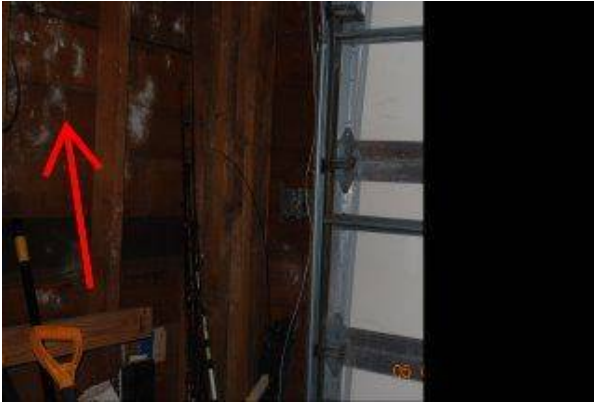
28) Garage exterior wall has no Insulation

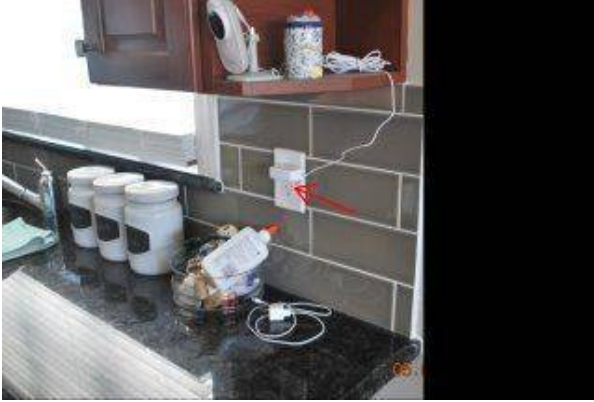
Photo 29-1
kitchen outlet not protected by GFCI and does not trip any other GFCI outlet in the area

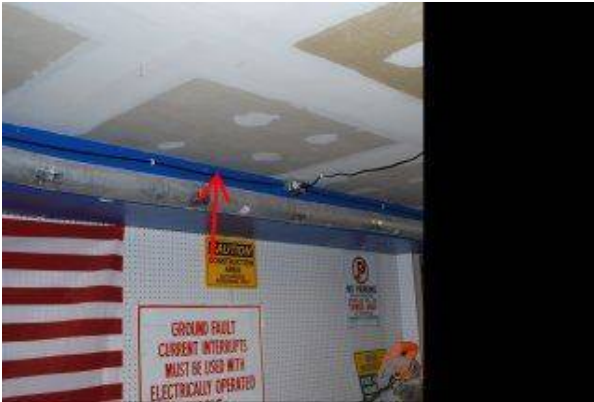
Photo 30-1
use of electrical extension cord as permeate wiring

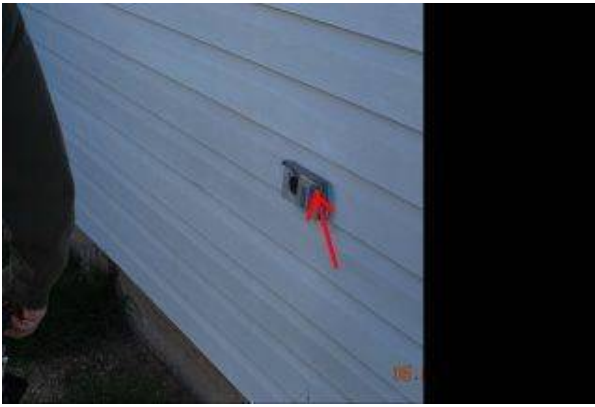
Photo 32-1
Broken exterior outlet cover

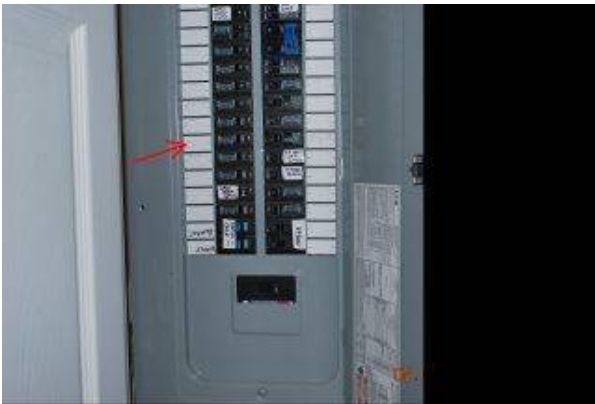
Photo 33-1
breakers missing labels

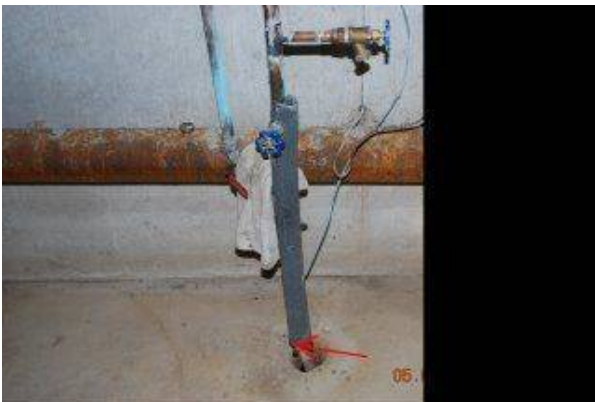
Photo 34-1
corroded grounding clamp

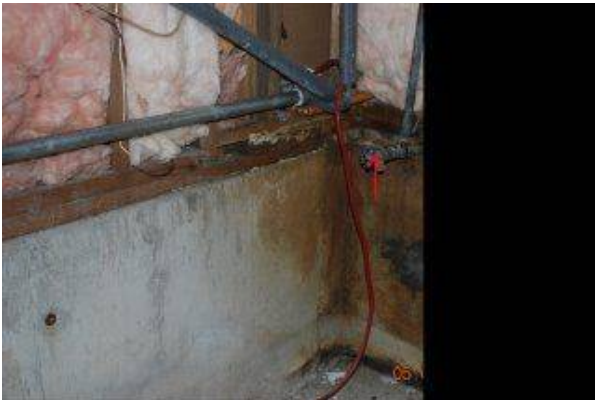
Photo 35-1
evidence of pipe corrosion

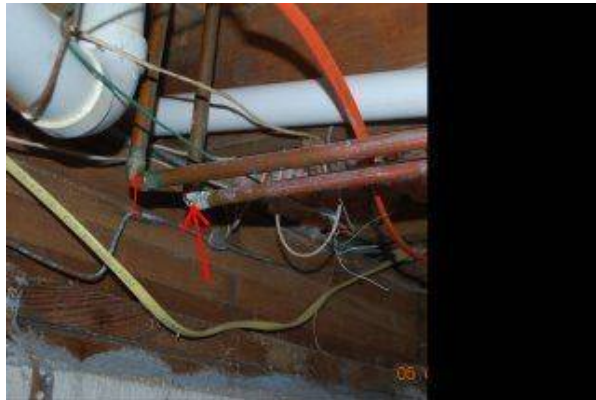
Photo 35-2
signs of corrosion at copper elbows

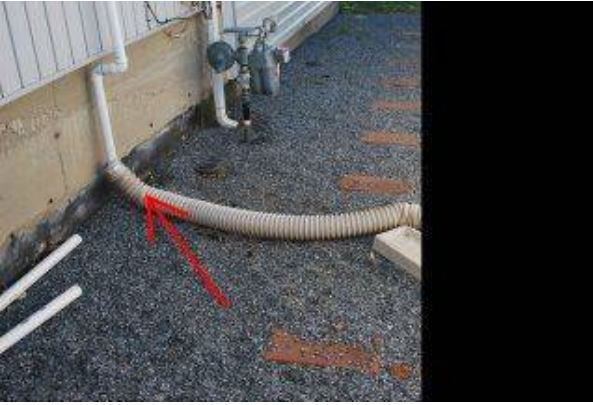
The sump pump discharge pipe was routed so that it drained close to the foundation. Prolonged, high levels of moisture in soil can cause foundation settlement and failure. If drainage is near a crawl space or basement, water can accumulate in these spaces. Recommend that a qualified contractor repair as necessary so the discharge pipe terminates well away from the foundation and to soil that is sloping down and away from the foundation.

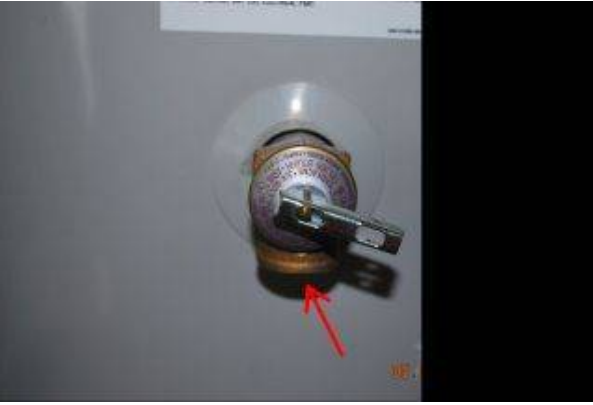
Photo 38-1
TPR valve missing discharge copper pipe

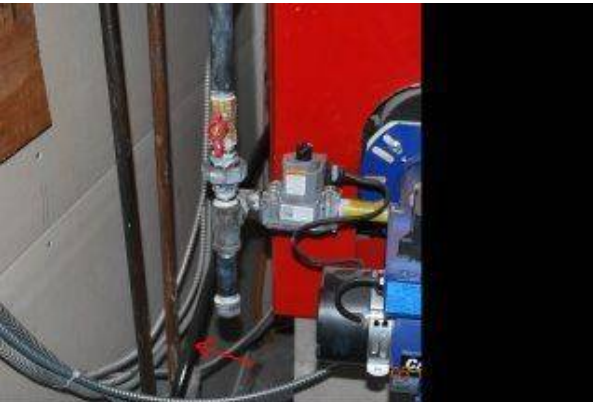
Photo 39-1
boiler drain hose made out of rubber

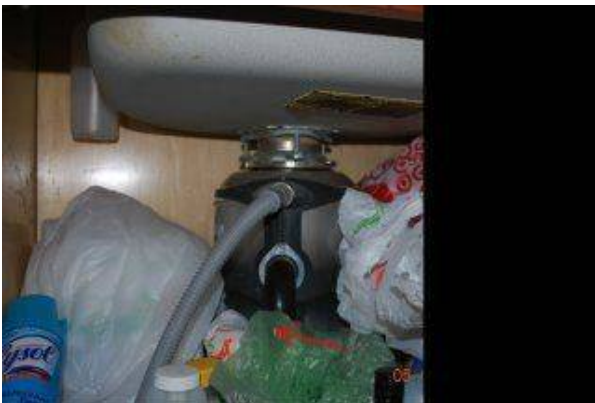
40) Plumbing under the sink was not fully visible

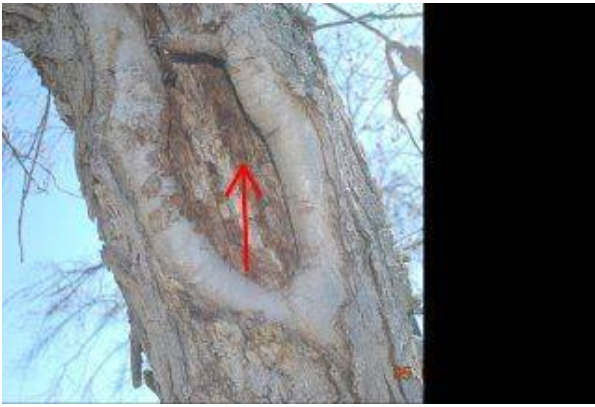
Photo 41-1
carpenter Aunt infestation at front tree

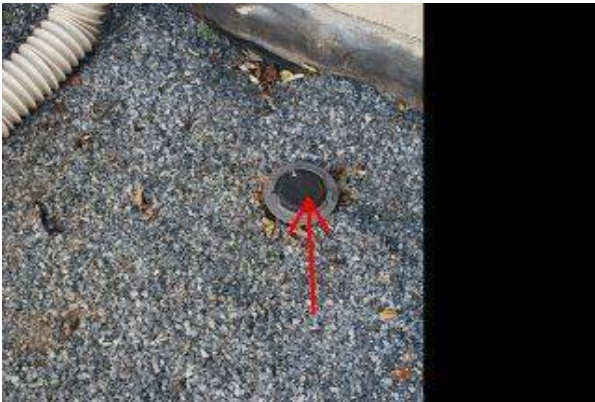
Photo 42-1
Evidence of prior Termite baiting system
